**Results of the Radiological Survey  
at the Former Associate Aircraft  
Tool and Manufacturing Company  
Site, Fairfield, Ohio  
(FOH001)**

HEALTH AND SAFETY RESEARCH DIVISION

Publication issued — March 1993

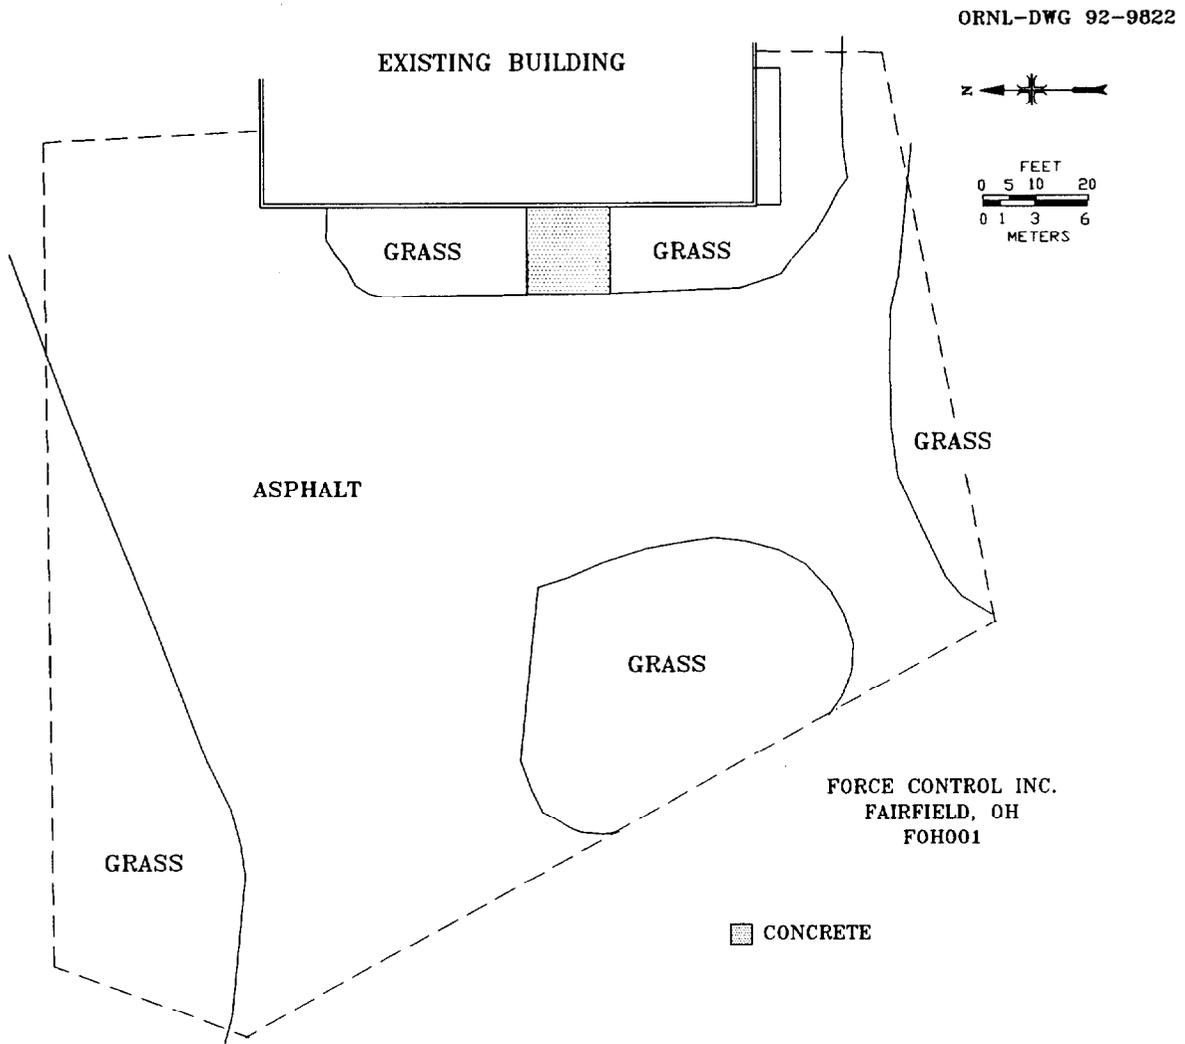
Photographs of the front of the building as it appeared in July and September 1992, respectively, are provided in Figs. 2 and 3. The ground surface directly in front of and west of the building was thoroughly surveyed in July prior to the construction shown in the second photograph. The complete radiological characterization of the building and of a 25-ft-wide perimeter of ground surface around the remaining three sides of the building was performed in September, 1992. The results of the two surveys are combined in this report. The approximate outdoor areas surveyed west of the building are diagrammed in Fig. 4. Figure 5 shows a floor plan of the building and indicates the six arbitrary sections into which it was divided, east to west, for purposes of identifying and locating measurements and samples. Most accessible indoor areas were scanned, and equipment and materials were moved aside wherever possible to allow access for surveying. At the time of the surveys, the owner operated a multipurpose machine shop in the facility.

**Fig. 4. Diagram showing the area surveyed (July 1992) west of the building at the former Associate Aircraft site, Fairfield, Ohio**

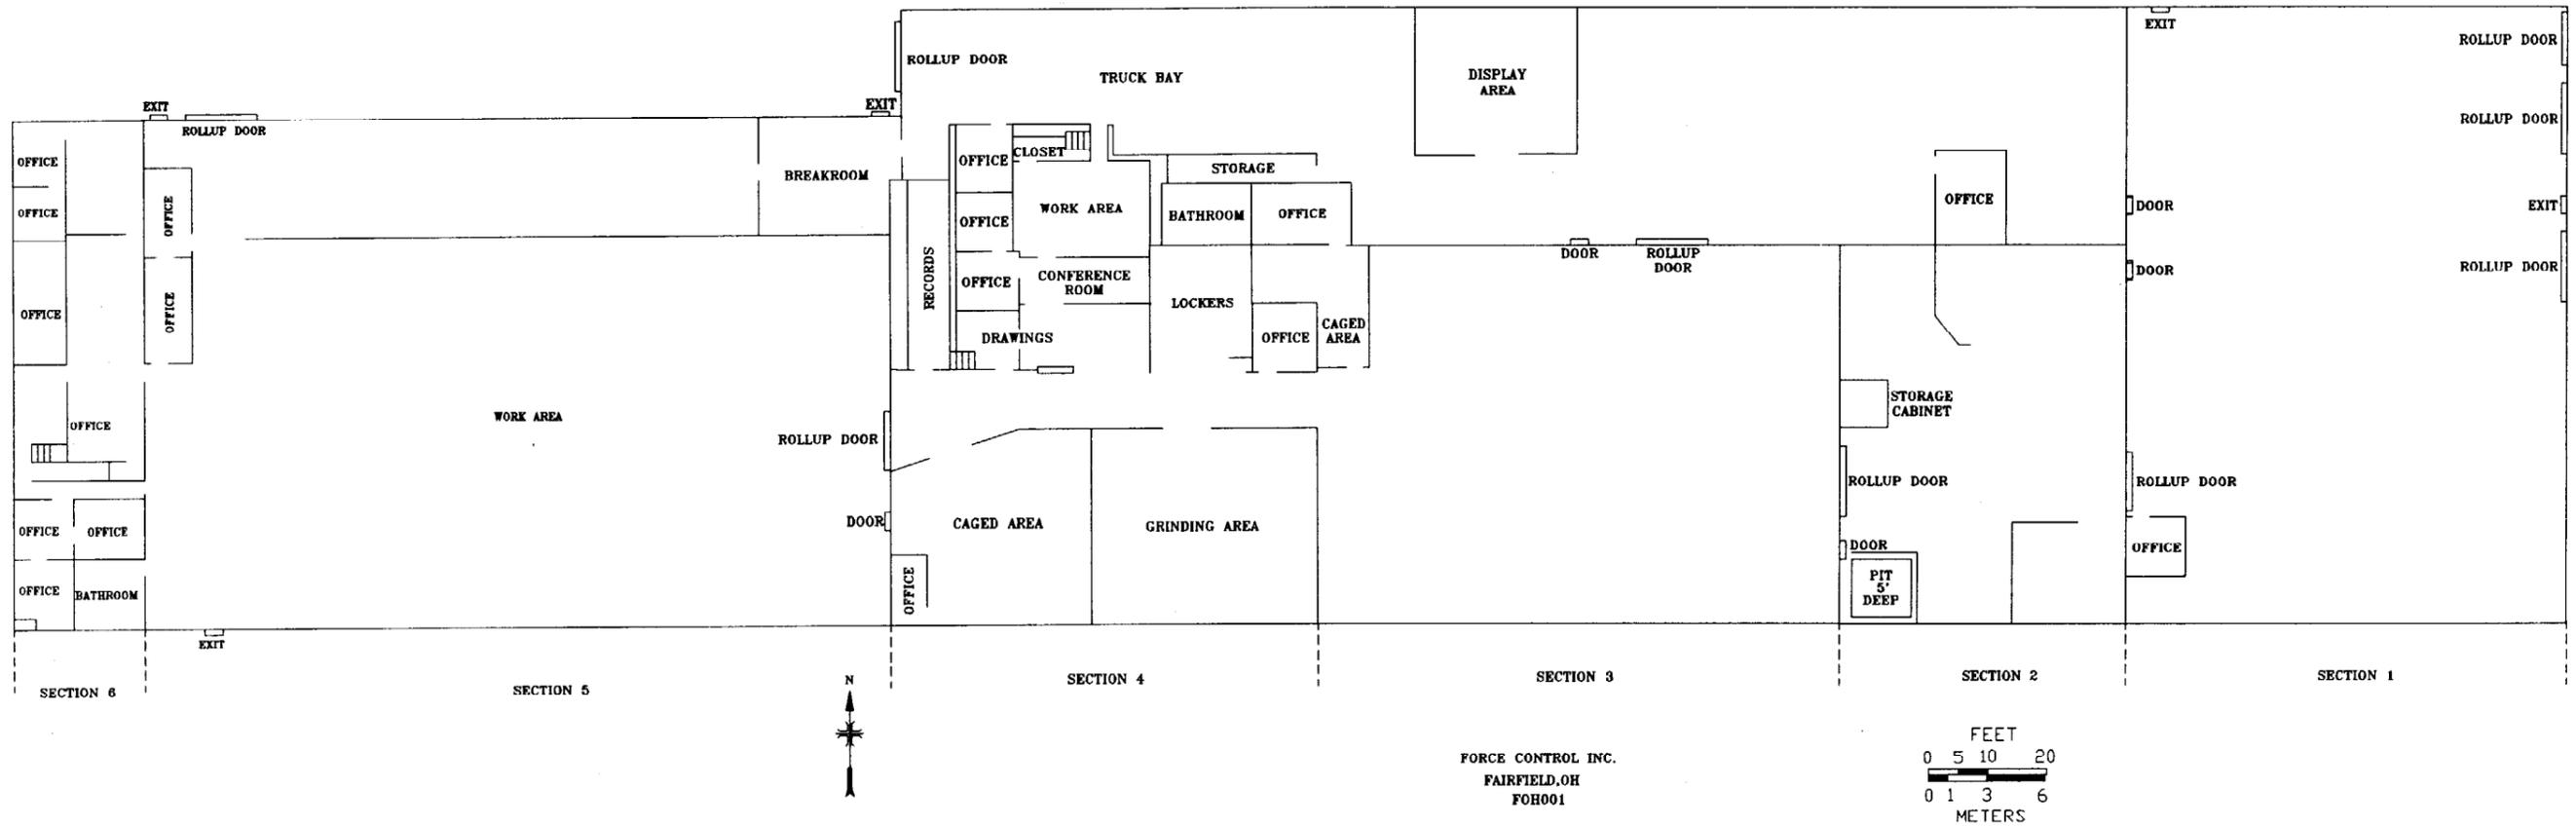
Indoors, direct radiation measurements in Sections 3 and 4 showed beta-gamma activity levels above guidelines in floor joints, cracks and seams, as high as 420,000 and 300,000 dpm/100 cm<sup>2</sup> (7 and 5 mrad/h), respectively. Concentrations of  $^{238}\text{U}$  were elevated in Sections 3 and 4 in dust samples collected from overhead areas (115 to 1900 pCi/g). Calculations using the sample areas, weights, and  $^{238}\text{U}$  content showed derived surface contamination levels as high as 3800 dpm/100 cm<sup>2</sup> that exceed the DOE guideline of 1000 dpm/100 cm<sup>2</sup> for removable activity shown in Table 1 by a factor of nearly four. Concentrations of  $^{238}\text{U}$  were also elevated from 2000 to 62,000 pCi/g in samples obtained from old floor drains in Section 4. Two very small areas of beta-gamma measurements in Section 5 exceeded guidelines. No anomalies were identified in Sections 1, 2, and 6.

Fig. 5. Diagram showing the floor plan of the building at the former Associate Aircraft site, Fairfield, Ohio.
